# ENERGY HYDROPOWER

## Madison Paper Inflatable Rubber Dam Bladder Replacement

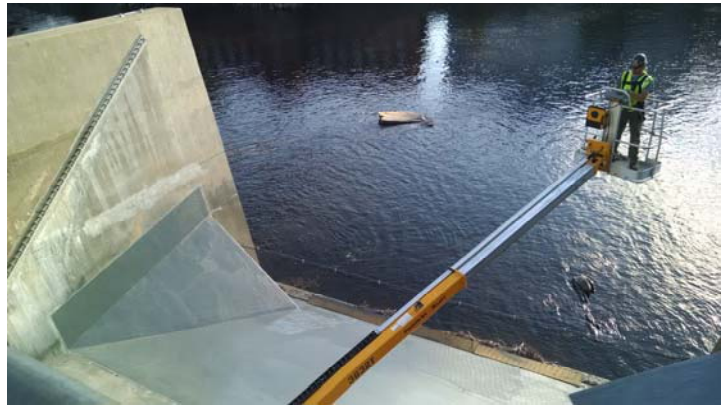
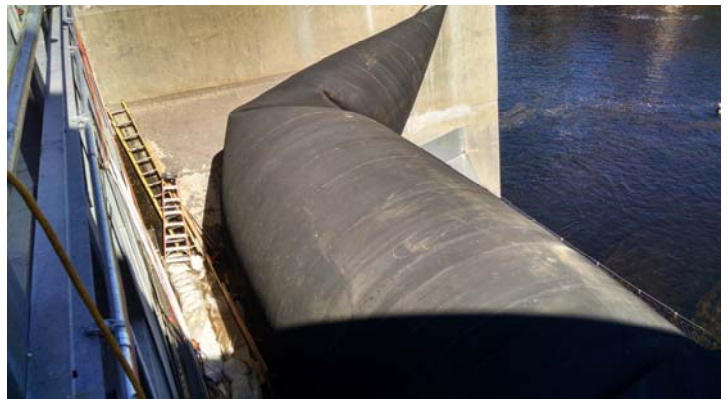
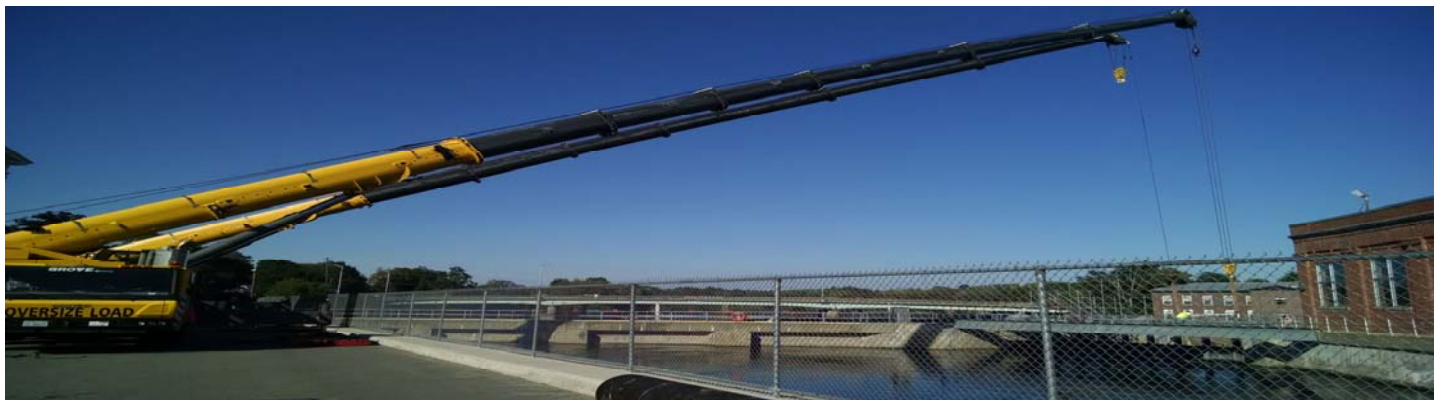
**CCB** provided access to the remote facility, completed the dewatering process and removed all clamping plates to remove the old bladder. We replaced damaged anchor bolts, repaired all concrete as required prior to installing the new rubber bladder.

To complete the project and lift the 52 ft. by 30 ft. bladder weighing 17,000 lbs to its final location 150 ft from the river bank, **CCB** utilized a "Twin-Crane lift." This allowed us to compact the schedule and deliver savings to the customer by not having to bring in a larger single crane. Spillway repairs and bladder prep took just over two weeks and bladder placement took 1 day. Final installation and testing took an additional week.
